RE: Ascente Trenches

Re:Seismic Findings Report Issues – Ascente Project

Refraction Seismic Investigation:
Ascenté Development Site
Prepared for: Lumos & Associates
Project Number: 2017-29.01 Date: October, 2017

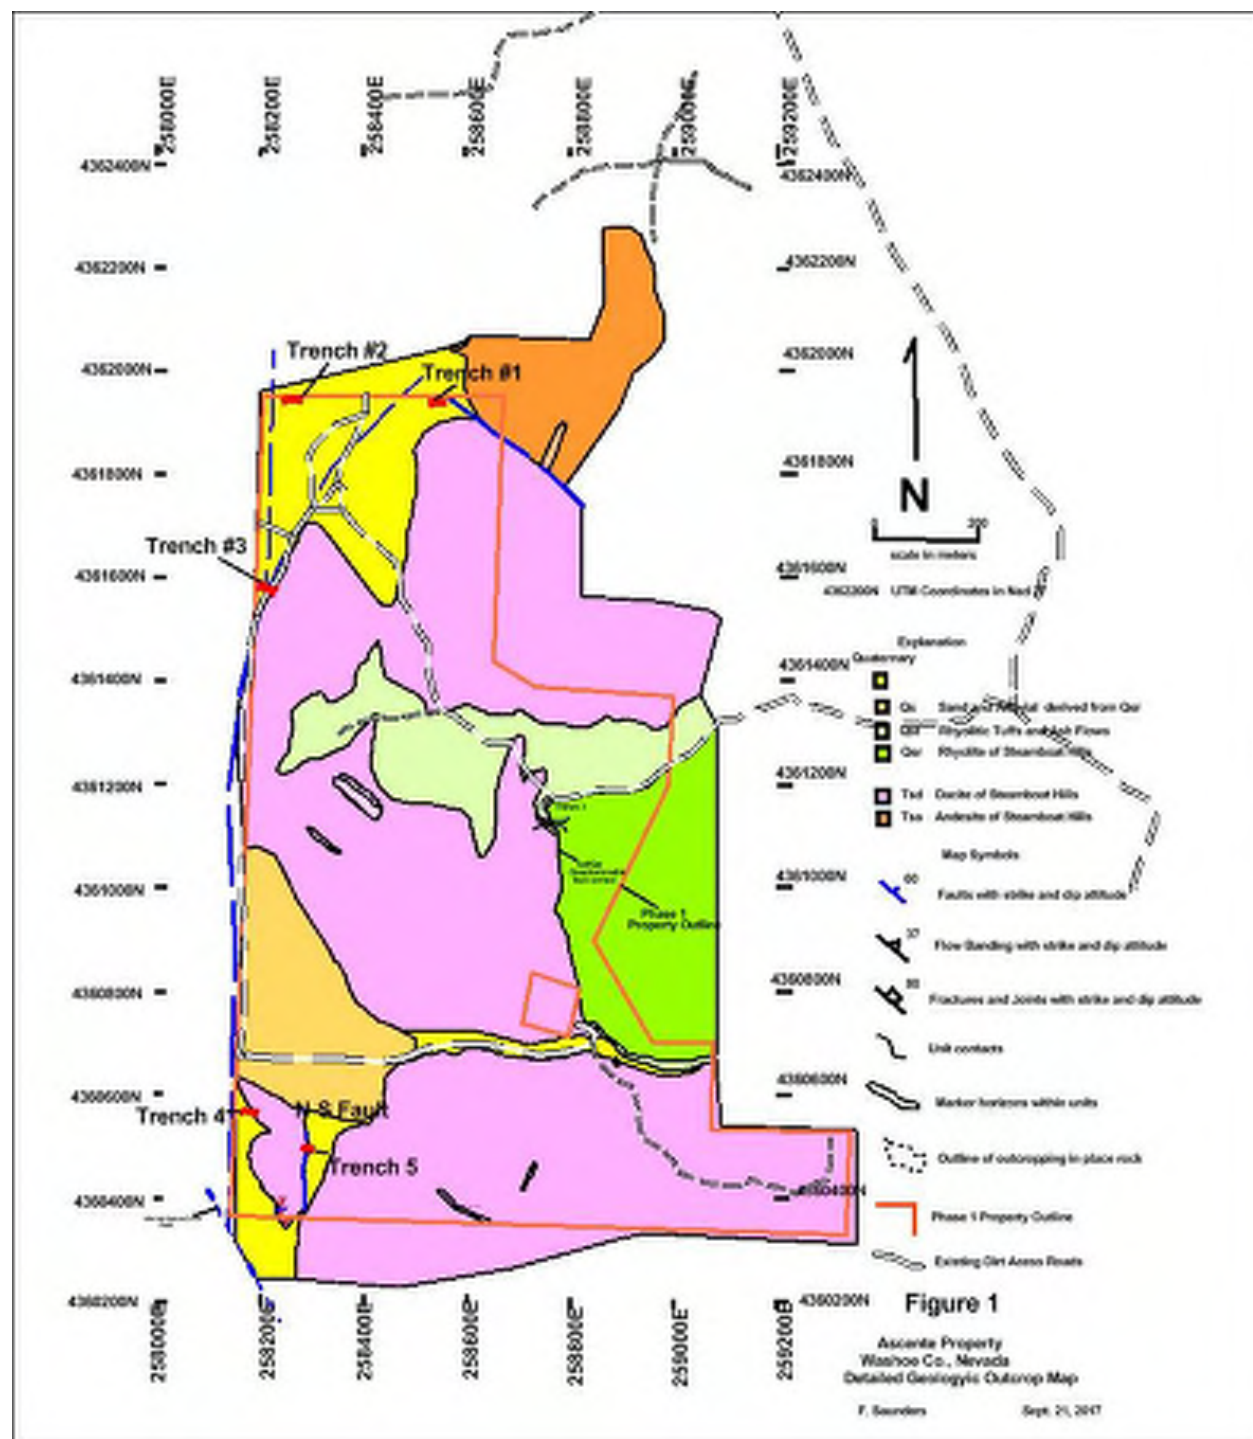
Figure 1 Geology Map showing 2017 trenches

I was contacted by Mitch Burns of Lumos & Associates (Lumos) to see if I would go out to Ascente Property and evaluate the trenching that their doing. The objective of the trenching is to determine if the faults previously mapped by geologist from the Nevada Bureau of Mines and Geology and myself actual exist and if they extend onto the proposed Ascente development (Figure 1 Fault and trench map of Ascente Property).

The east-west trench was only 40 feet long. The west end of the trench was cut down 4 feet to outcropping dacite. At about $\frac{1}{2}$ way in the trench the fault was cut. The alluvial had a marked color change and represented a sharp drop off of basement depth. The trench was cut 15 feet deep on the east side of the fault and never encountered bedrock, thus indicating a vertical offset. This fault will need to have a 50 foot offset designed in the Ascente plot plan.

The projected core hole located east of the trench could be moved closer to the trench to see if it encounters bedrock at a reasonable depth.

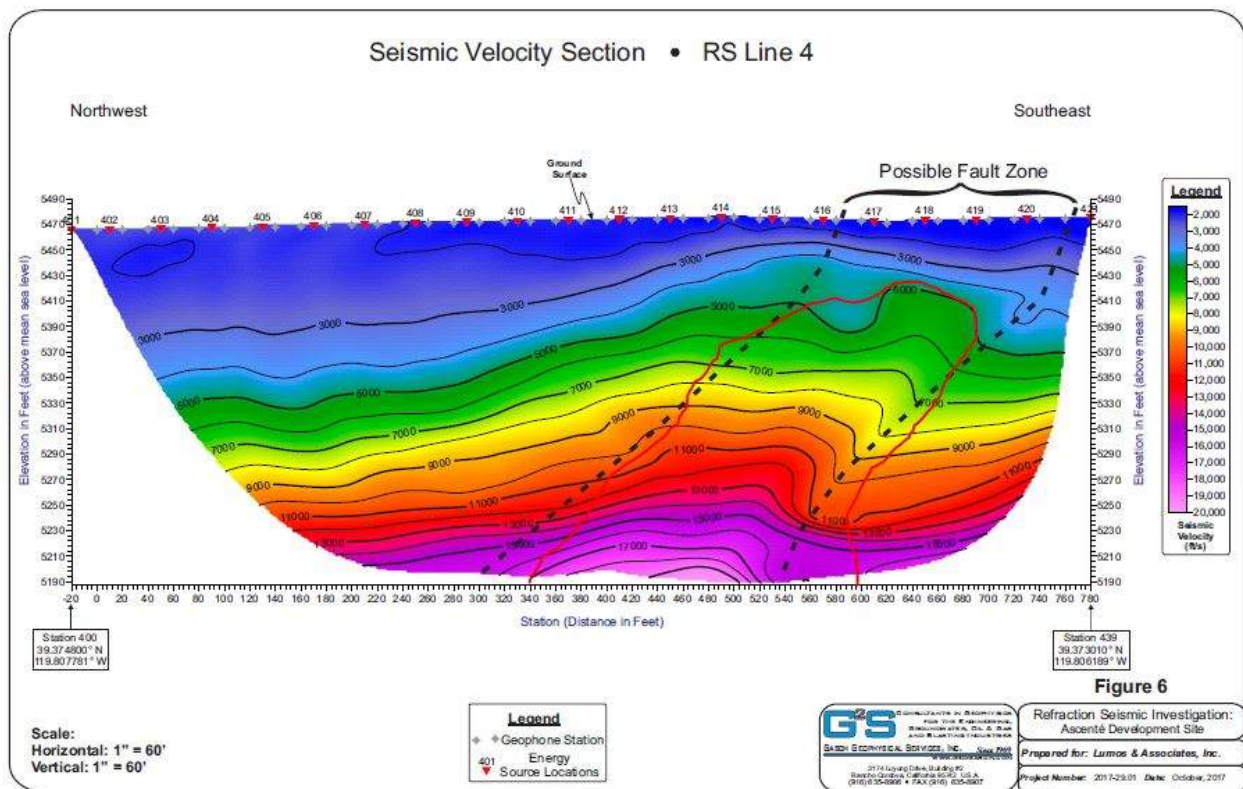
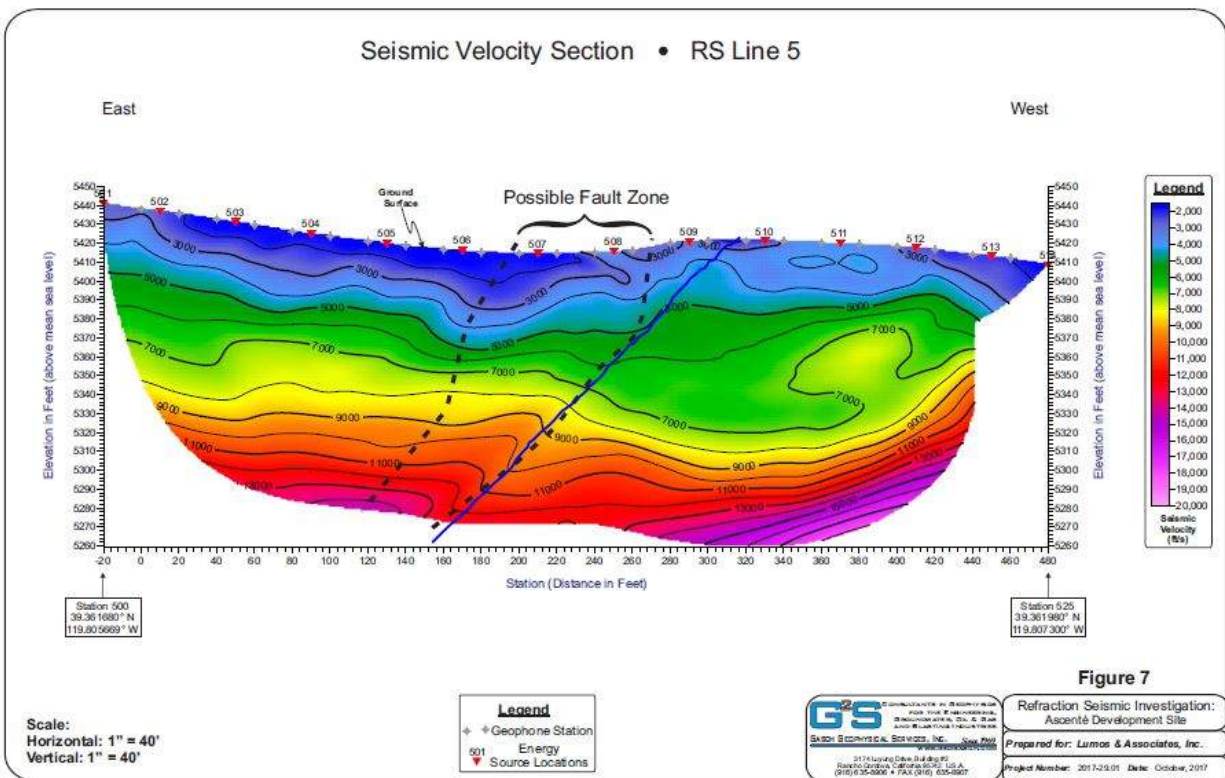
GES seismic lines RS-4 & 5 with new interpretation.

I reviewed the report and feel the possible fault zone in seismic line RS -4 could be reinterpreted as a bedrock or basement high. Seismic geophysics essentially measures variances in the density of the material that it encounters and reflects various sound waves velocities back to the surface. Denser rocks such as outcrops will reflect higher velocity sound waves than lower density rocks such as alluvial.

If you compare Line RS-4 to line RS-5, where in line RS-5 we definitely hit the N-S fault that that can be seen on the google earth base map of GES. In line RS-5 There is a marked break in seismic profile right at the fault, (shown in blue on my figure below) showing a decrease in wave speed on the hanging wall side of the fault. Indicating this a normal fault dipping eastward with a small downdropped displacement on the east or hanging wall side of the fault which is what we saw in Trench 5. This is typical of horst and graben faulting within the Basin and Range Province of Nevada.

Line RS-4 on the does not show this same pattern. It shows a zone that GES has outlined as a possible fault zone in the Seismic Velocity Section – RS-4 as a higher density material surrounded on both sides by a lower

density material. Indicating this a bedrock high surrounded by gravels or alluvial shown in red on attached Seismic Line RS-4 profile.

A shallow (100 feet deep) reverse circulation drill hole located in the center of the high on seismic line RS-4 would test the bedrock extension and hopefully help resolve the question.

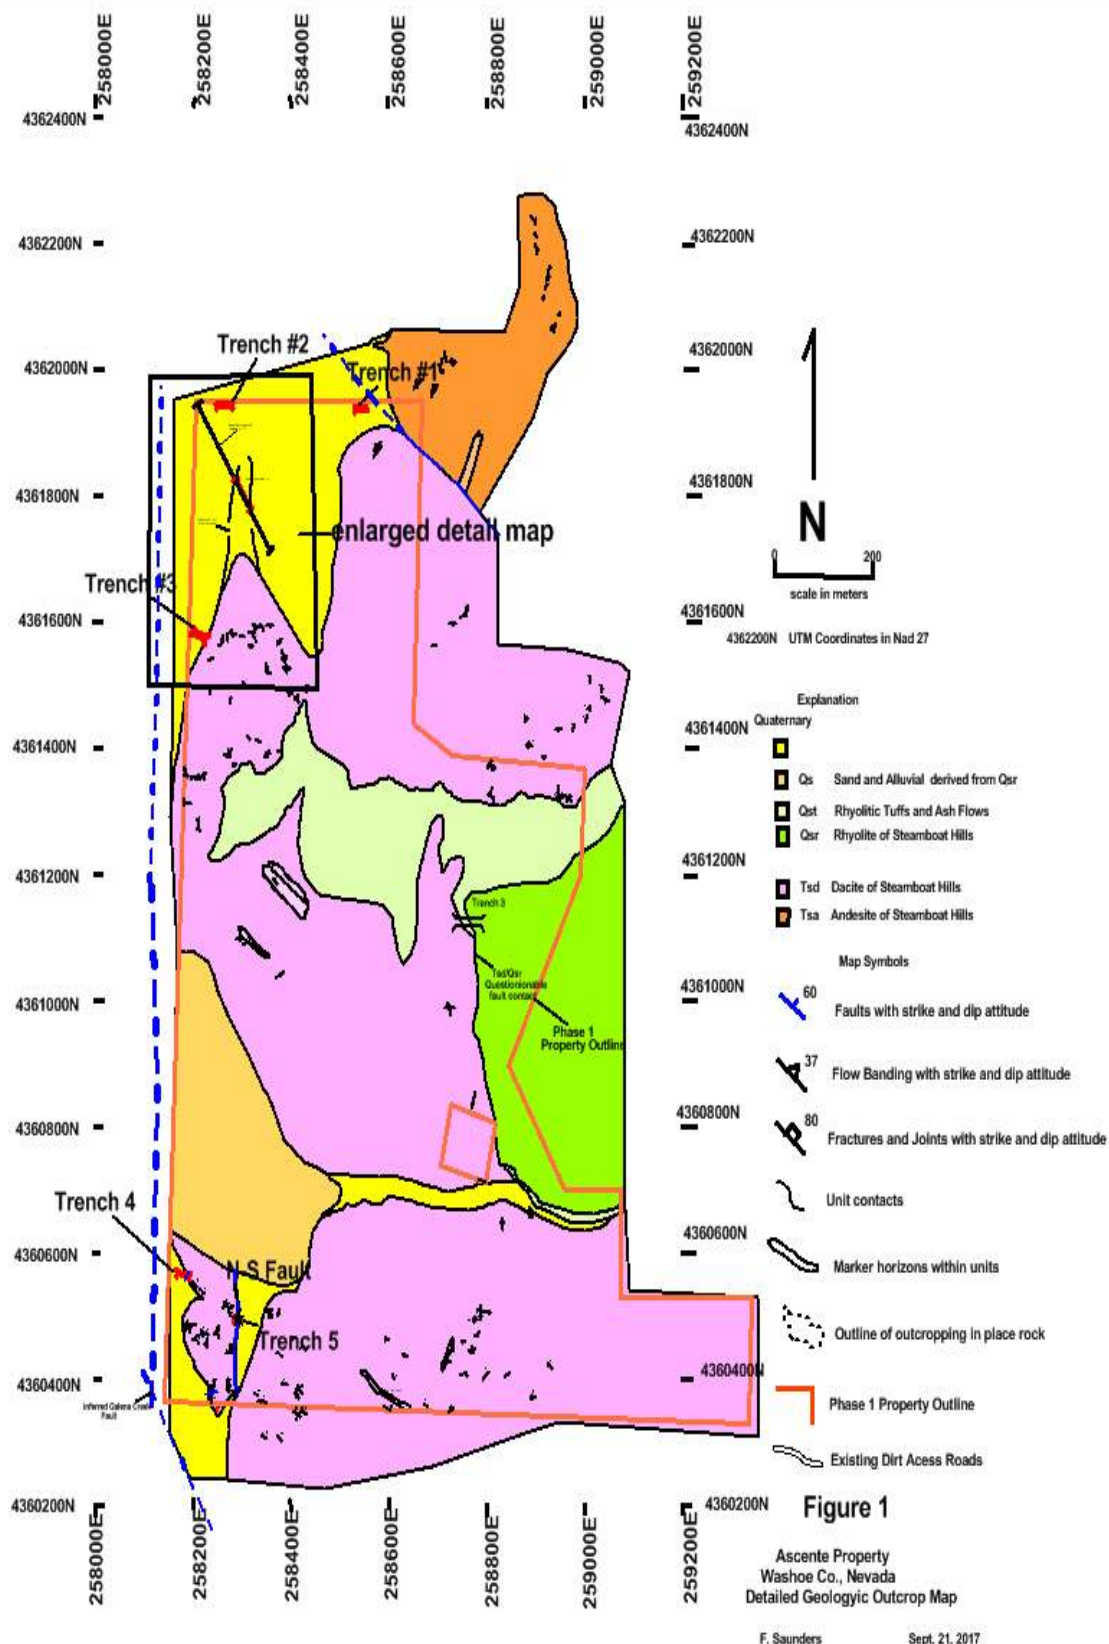
Ascente Geology map showing block of enlarged area and seismic line RS-4.

This seismic anomaly is located just north of an outcropping ridge that is interpreted to extend out under the alluvial to the north as shown on the attached Ascente Geologic map and enlargement map . The attitudes, although somewhat chaotic on the geologic map, due roughly indicate that the outcropping ridge of dacite bedrock is elongated in a north-south direction and dipping back to the west, which is what the seismic data indicates.

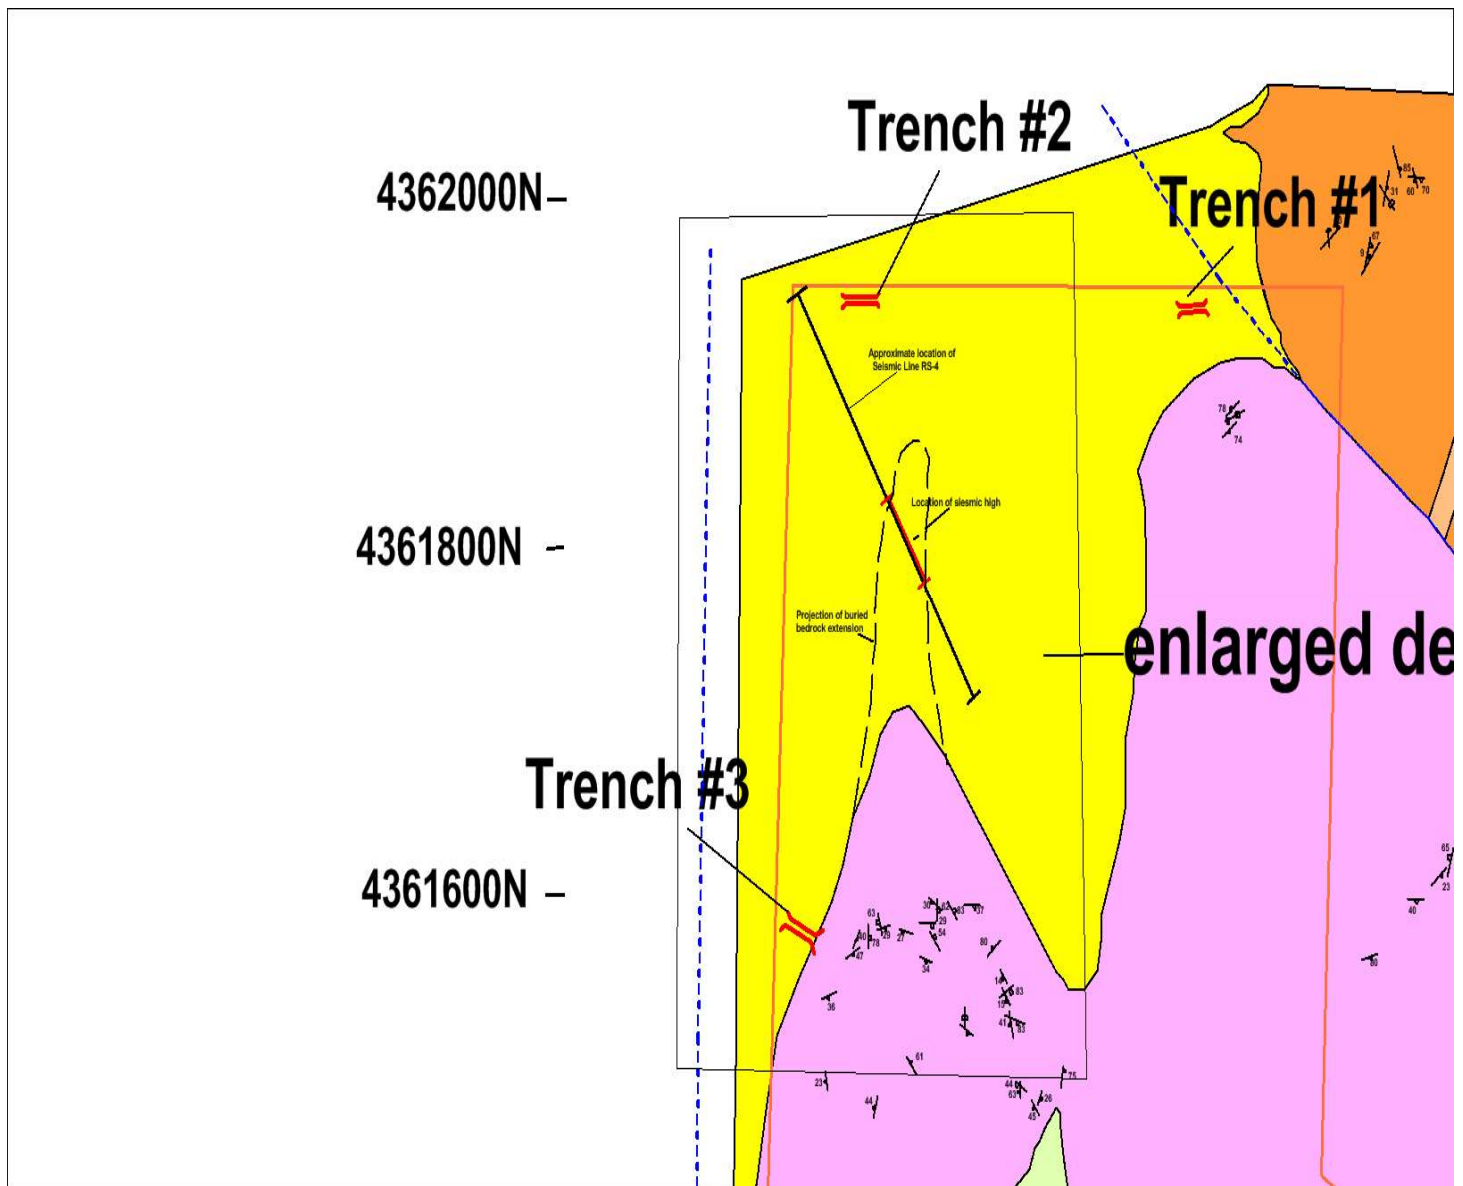
Enlarged Ascente Geology Map with Siesmic line RS-4 and Proposed bedrock extension.

Other less likely, but possible options could be it is an intrusive high similar to the rhyolitic intrusive located ½ mile to the southeast. The chaotic nature of the flow bedding attitudes also might indicate that this maybe an older vent area for the volcanics.
