Mr. Trevor Lloyd, Senior Planner

Washoe County Planning Department

Subject: Lumos Associates Field Geotechnical Investigation September/October 2017

Paleoseismic studies of the Little Valley fault

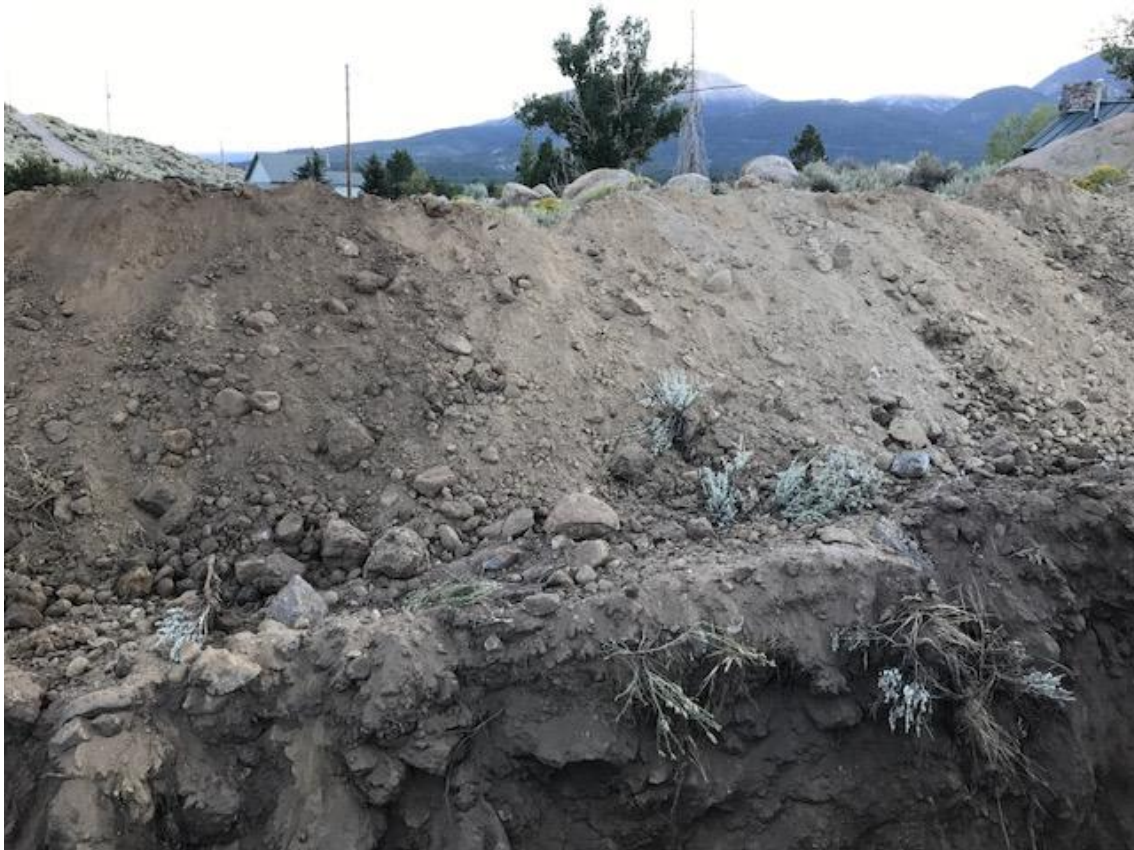
3) Chip Porter and I visited the trench dug on the western property border along the dirt access road. We could see the fault as evidenced by the change in lithology, as shown in the photos below and suggest that it is the concealed fault previously identified by the NV Division of Mines and Geology. Chip noted that the trench wall was not shored even though it was over 8 feet deep, and the wall was not scraped smooth to better reveal the fault scarp and related geologic materials changes within it, as is professional practice. We don't have the Lumos trench logs but we understand from our on-site conversations with the Lumos contract geologist, Frank, that he logged several trenches in one day! Chip states that during his professional practice as an engineering geologist, he logged around 100 feet of trench per day, given good conditions and uncomplicated geology. It is not plausible that the trenches could be adequately logged so quickly. Photos of the trench walls showing the observed fault are included below.

Photo 1 – South wall of trench along west side of Ascenté property boundary, showing fault trace, as seen by change in sediment color. NOTE were not scraped smooth, as is good professional practice.

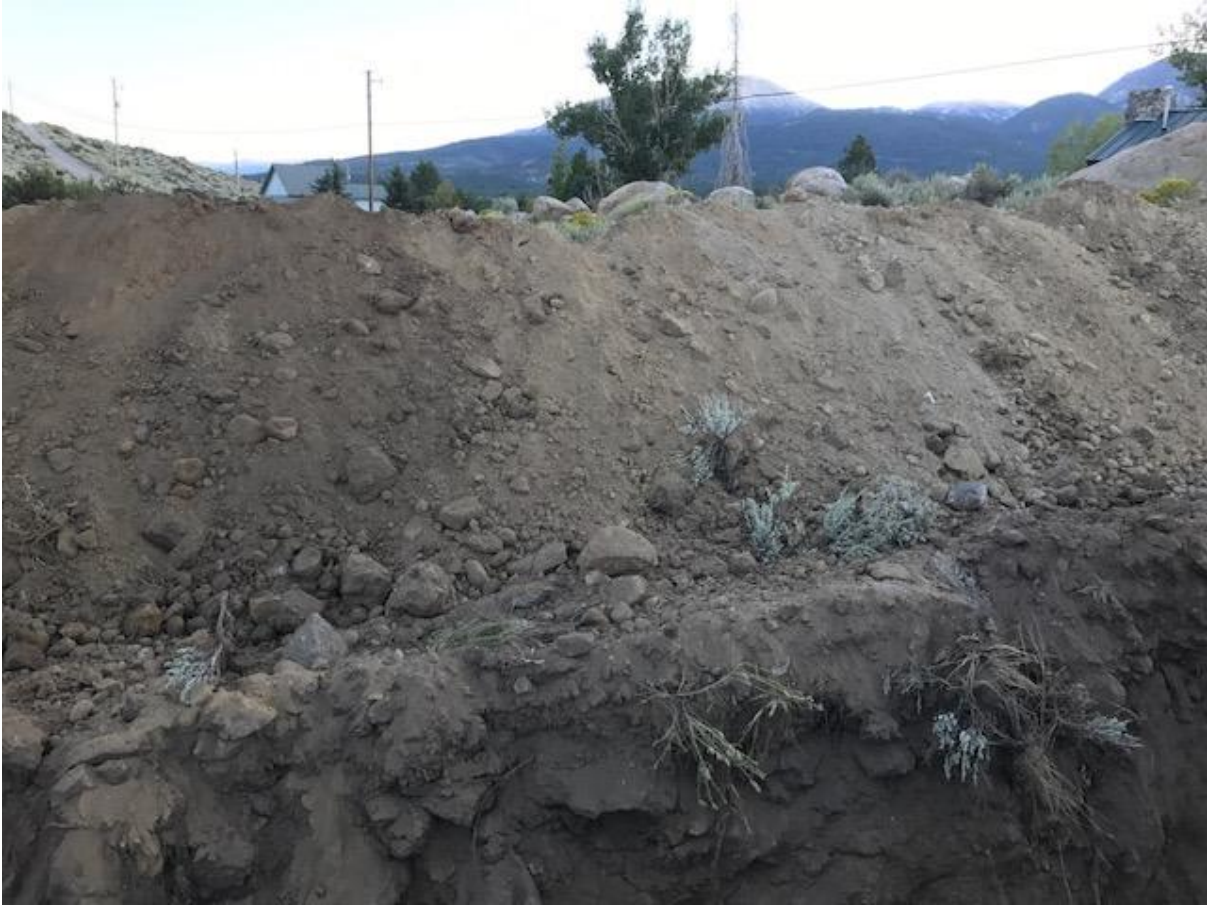
Photo 2 – Trench cuttings revealing lithology change at the central west side of property, just south of Brushwood Way.

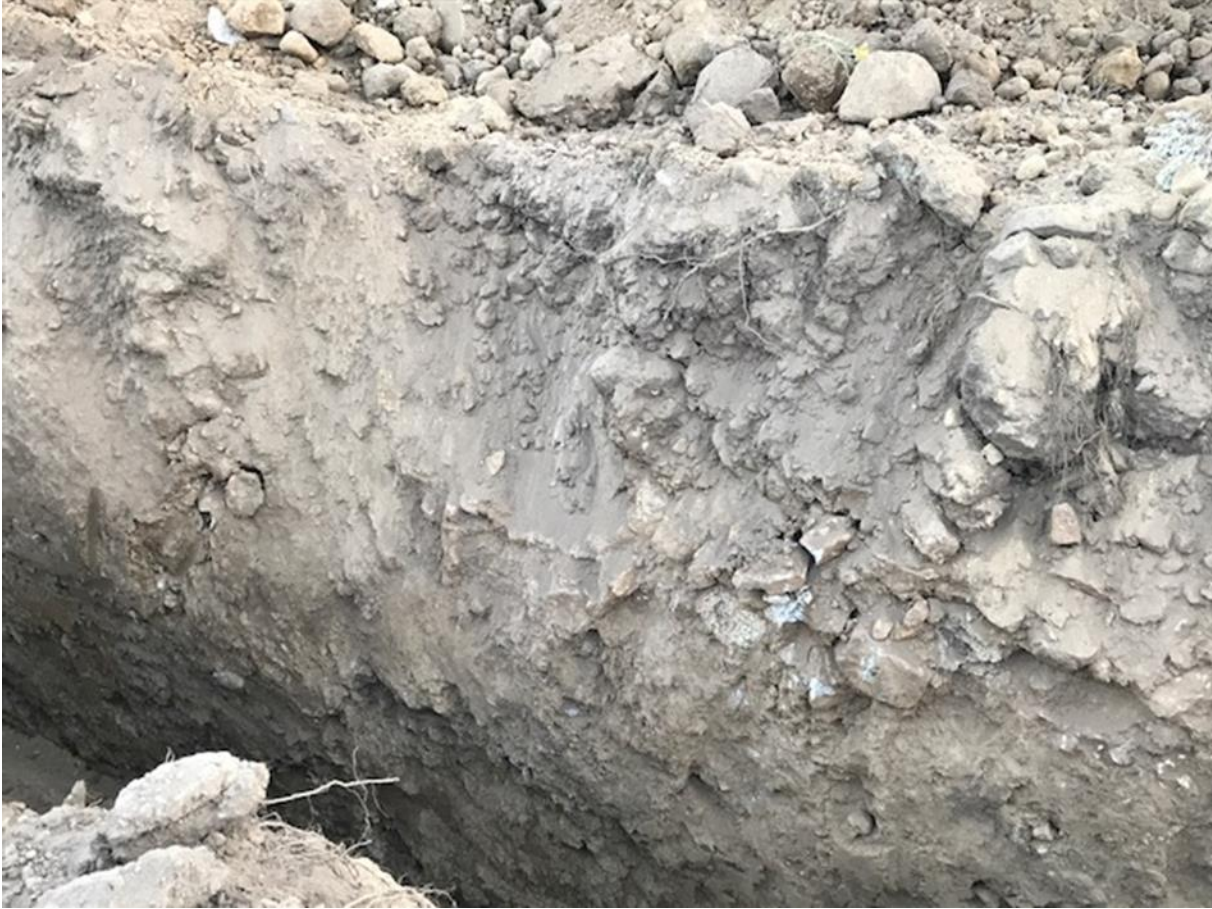
Photo 3 - Fault trace in trench just south of Brushwood Way on west side of Ascenté property. If the trench walls had been scraped smooth, the changes in the rock facies would have been more apparent.

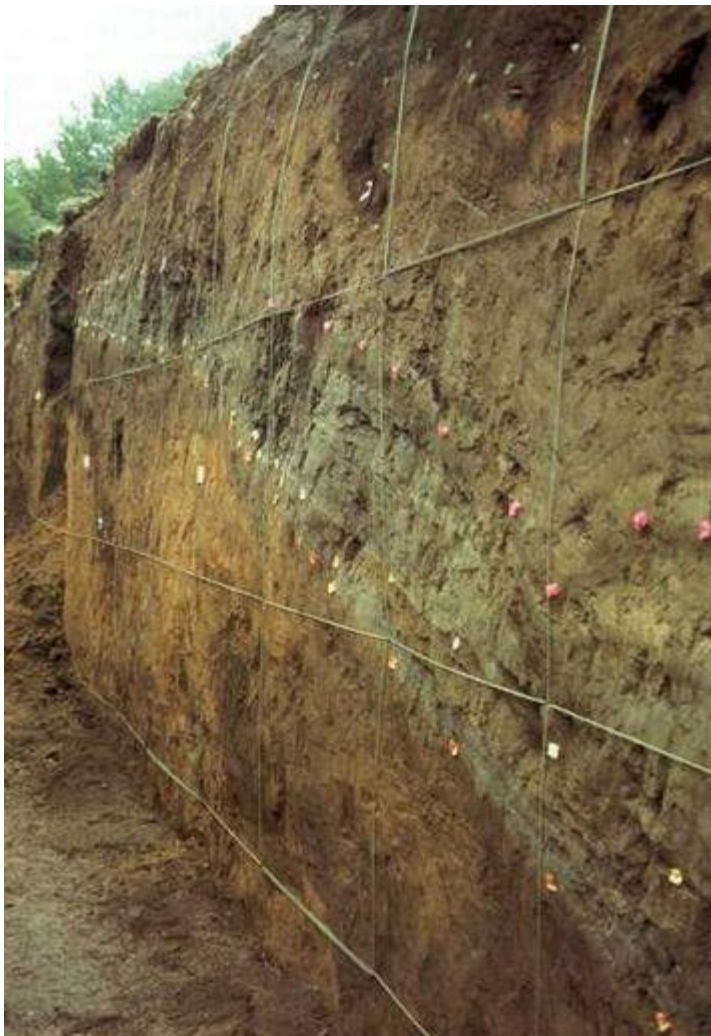
Photo 4 – Example photo of a trench wall with flagging and reference net. In this trench across the Irpinia fault (Southern Italy) the fault zone appears as a warping of sediments and ground surface.

As shown in Photo 4, the trench wall is scraped or cleaned to reveal lithology and geologic features. Important features are highlighted by painted nails or little colored flags, called “pinning or flagging”. Another important step in preparing a trench for detailed geologic mapping is the setting of a horizontal

and vertical grid formed by squares of a pre-determined width (feet or meters) outlined by string or twine. These serve as a reference for logging trench walls and for correlating features to other trenches at the same site.

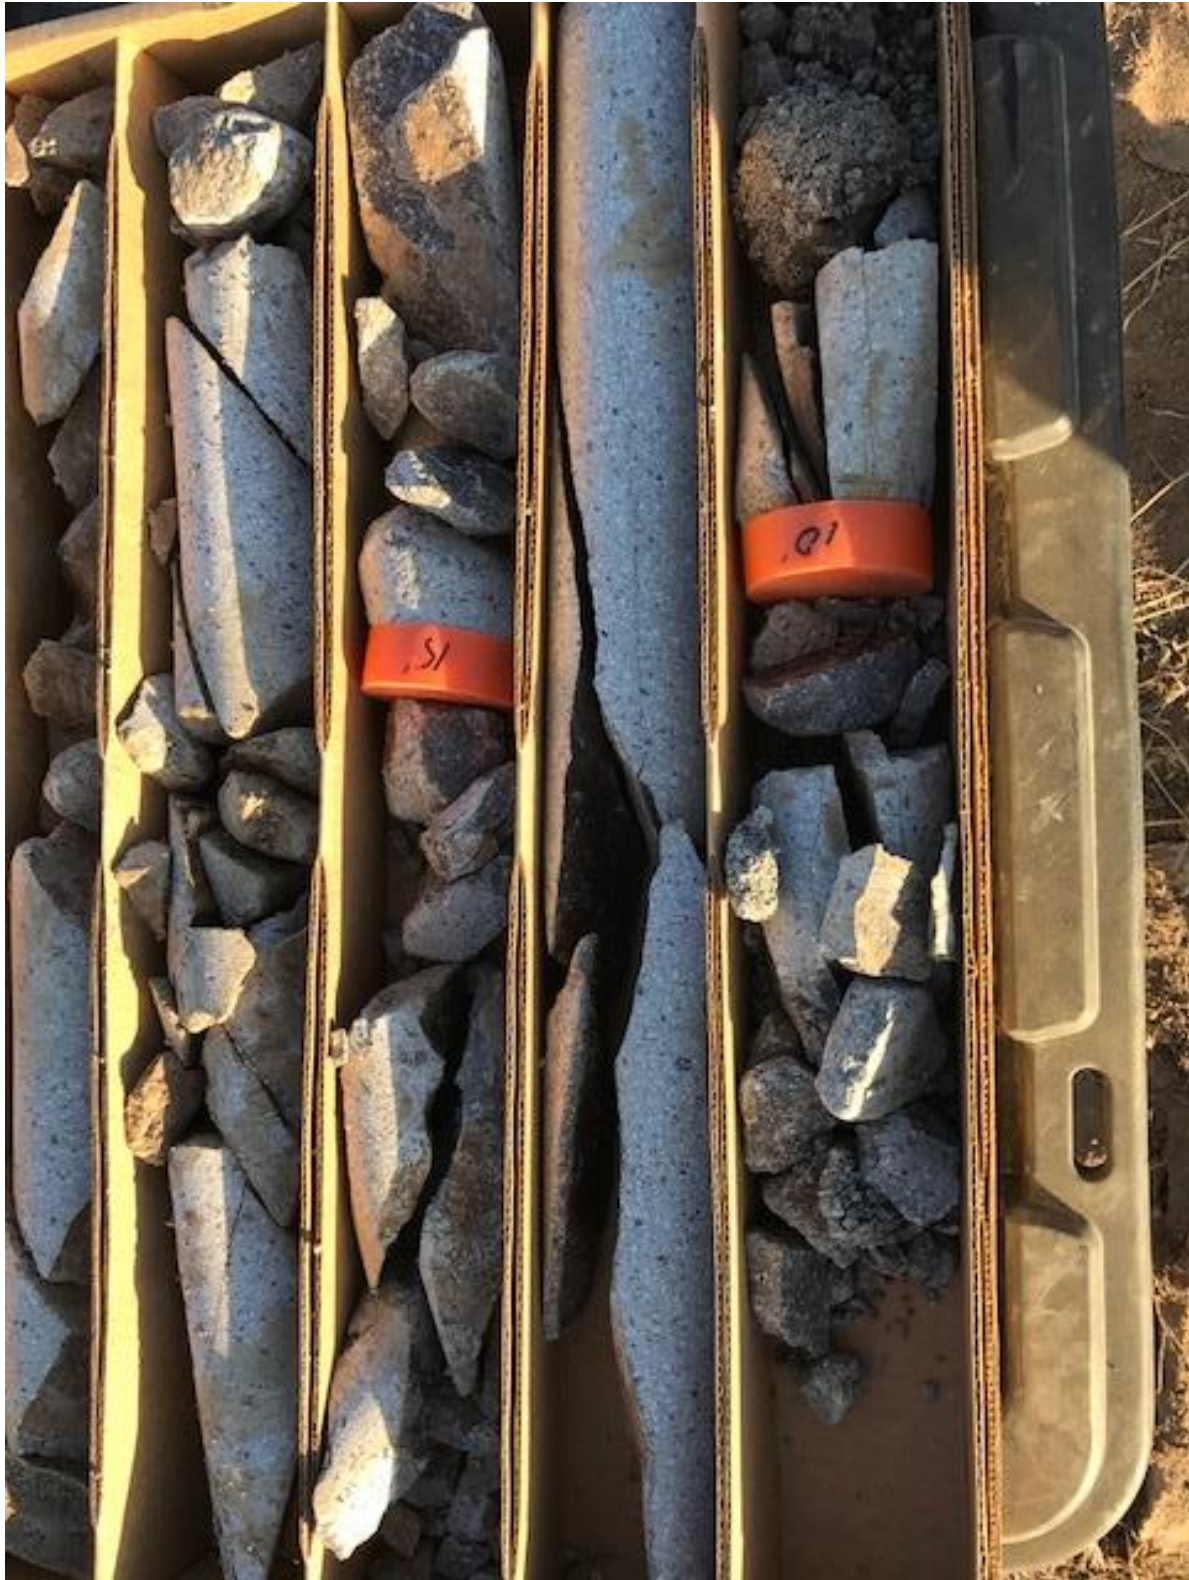
5) On September 29, we observed the contents of a drill core box left at a drilling site on the southwest corner of the property, about 200 feet south of the water tank access road. I took photos of the core and noted that labeling on the boxes left much to be desired. The core rock labeling, and the condition of the core itself indicates that drilling hit fault gouge at 8 feet, and then fresh fractured diorite/andesite bedrock from 10 - 20 feet. Both of these features indicate the presence of a fault. No core was collected after that depth but the core box doesn't indicate that 20 feet is the final depth. The hole was at least partially filled with bentonite chips and then the empty bag was stuffed over top. It wasn't apparent whether the drillers poured water down hole to activate the bentonite and thus seal the drillhole. Three photos of this core are shown below.

Photo 5 – Core Box from drillsite at southwest Ascenté property, south of Patti Lane.

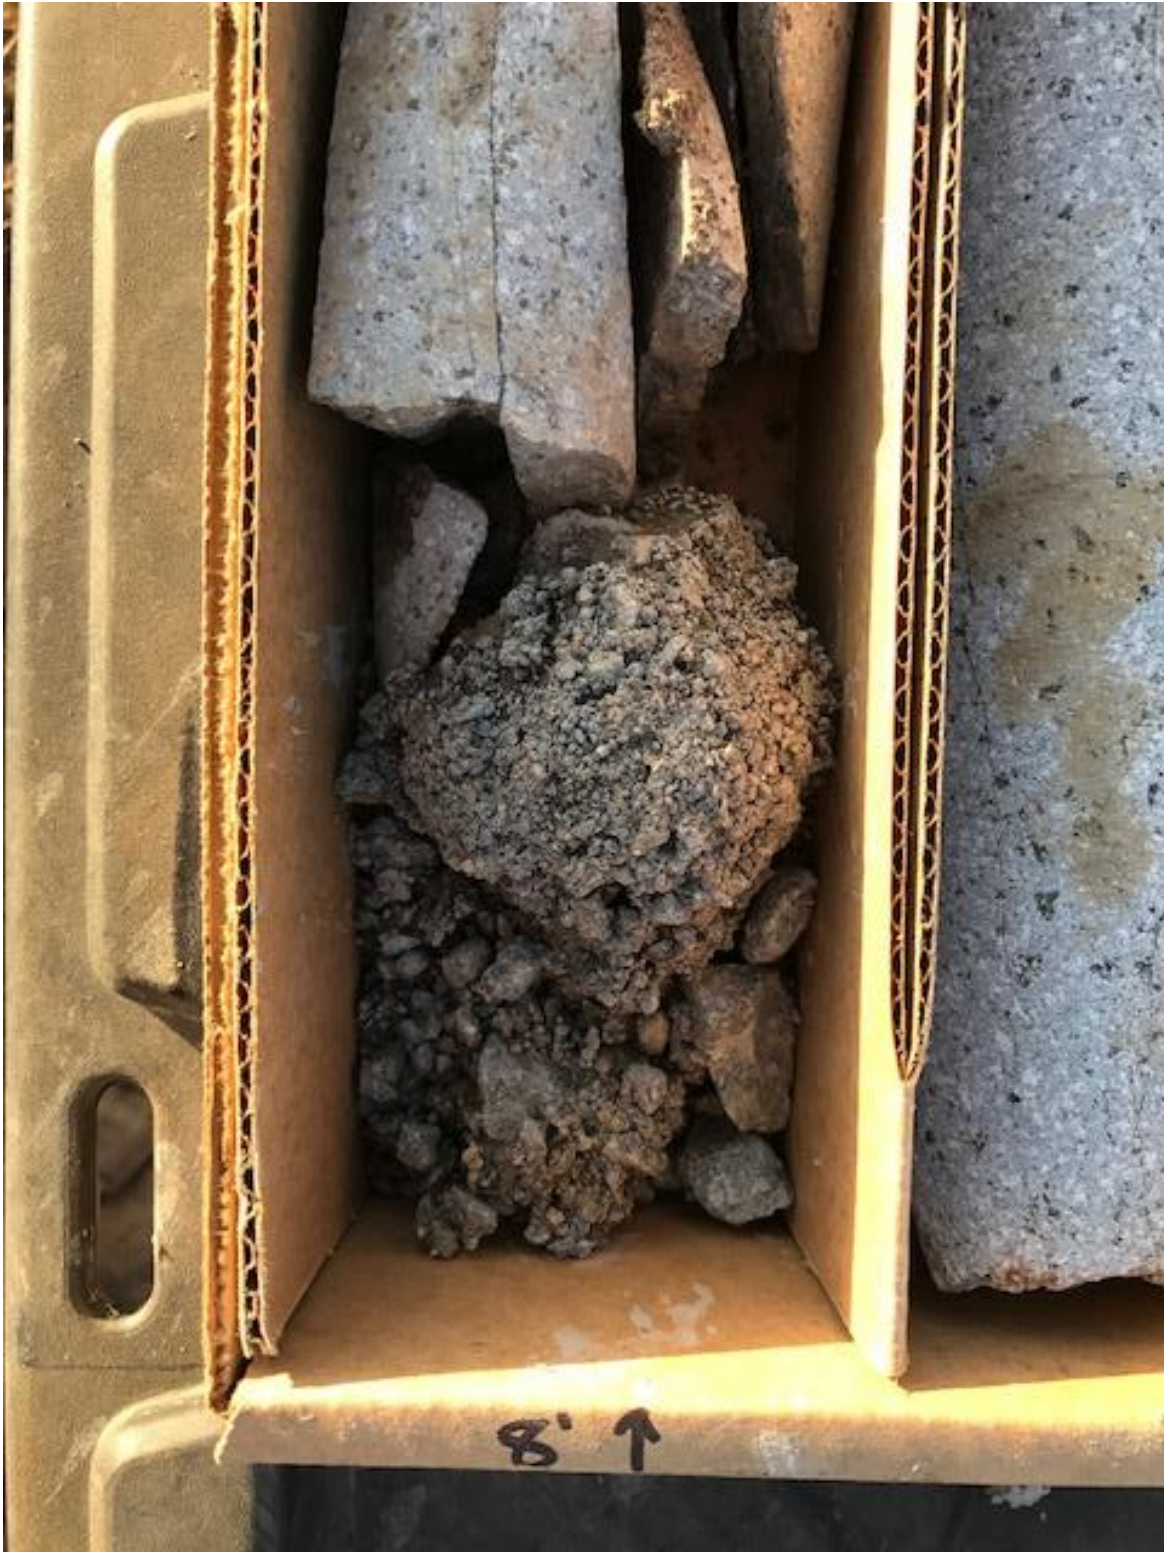
Photo 6 – Core box contents at 8 feet depth, evidence of fault gouge.

It appeared that some of the fractures in the core at the 8-foot zone had slick surfaces, suggesting movement. Did or any of the other planer zones in this drillcore or core from the other drillholes contain fractures and/or slickensides? A slickenside is a smoothly polished surface caused by frictional movement between rocks along the two sides of a fault. Sometimes the drill bit hits a fracture zone or groundwater fracture flow boundary and the drill rod washes out with no intact core. Did they core fractured rock from 0 to 8 feet, or soil, or solid rock? Detailed drilling and core logging records, if professionally done, will record this information which is important for foundation planning.

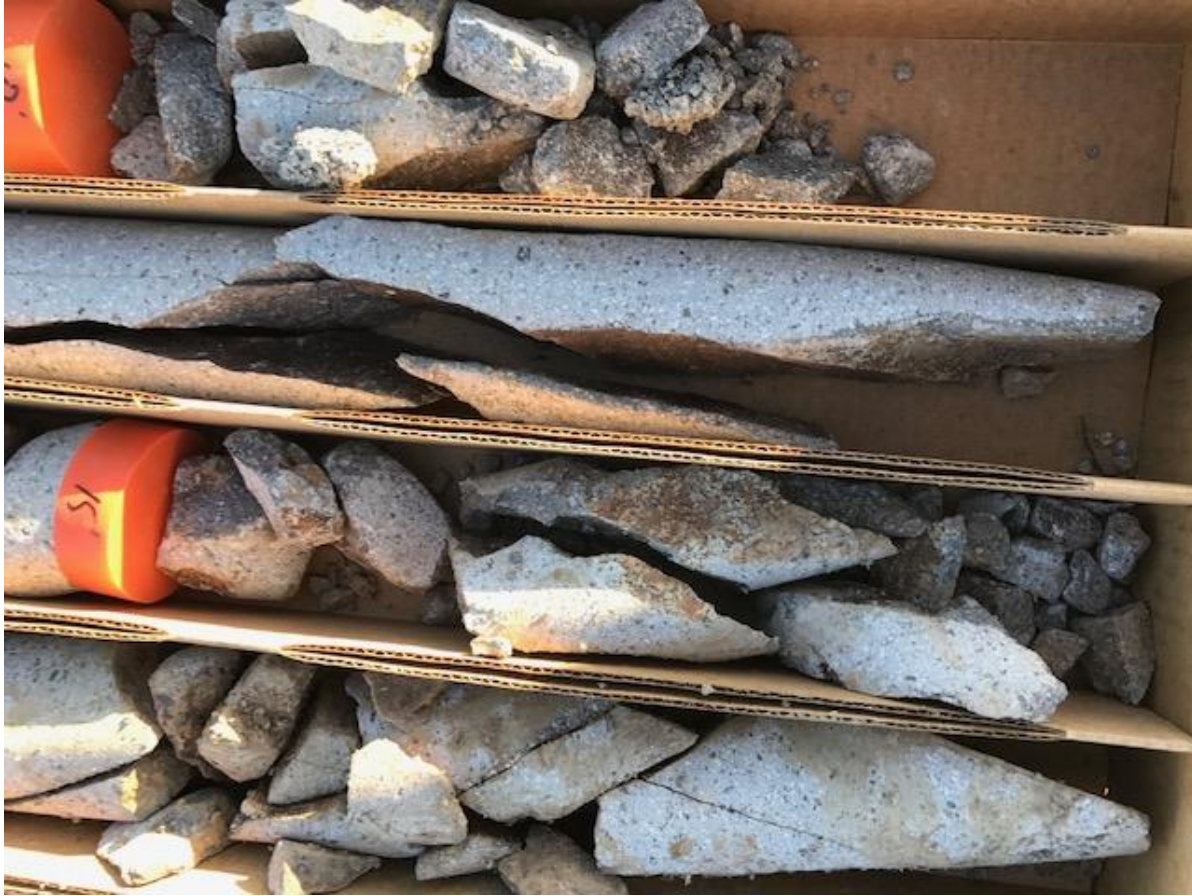
Photo 7 – Core “loss” at 0 – 8 feet. Why was core not collected from the surface to 8 feet?

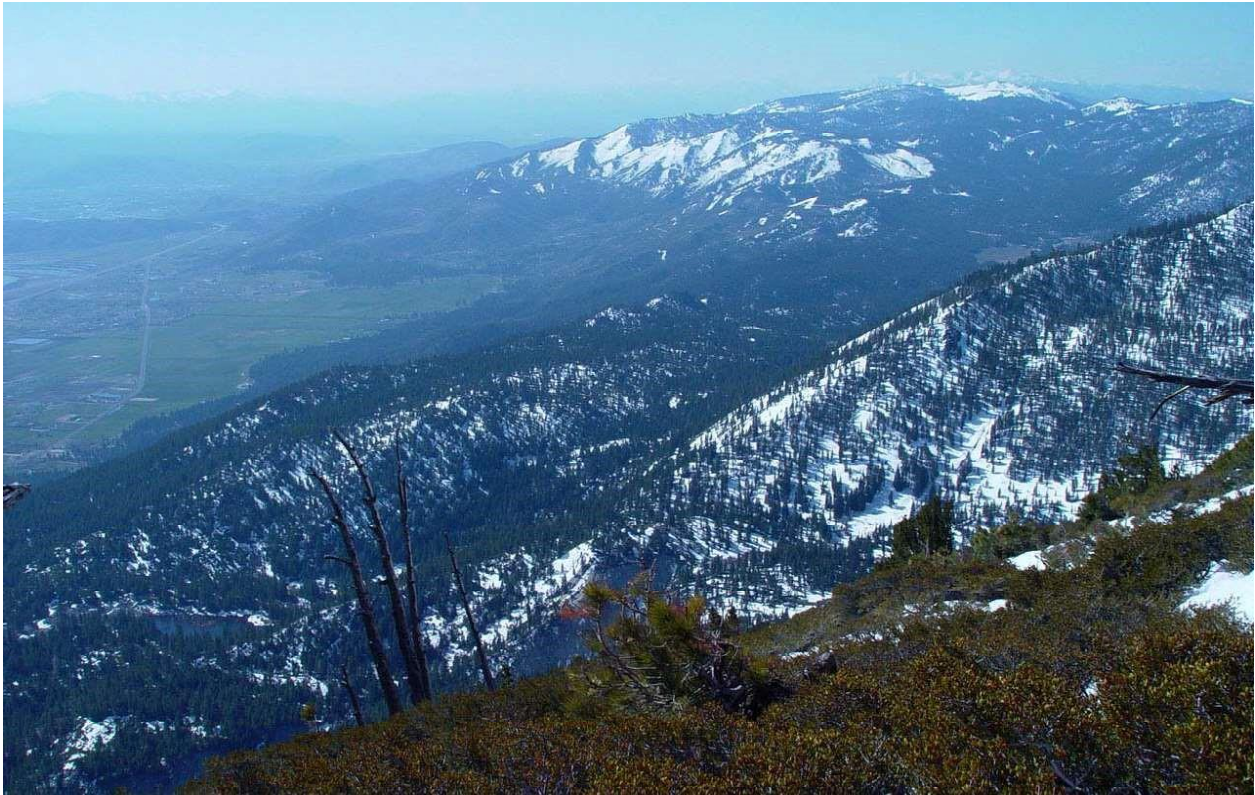
Figure 2: Washoe Valley (to left) and Little Valley (center) looking south from Slide Mt

The Little Valley fault is synthetic to the range-bounding Washoe Valley fault (figure 2). The two faults have similar topographic relief (~600 m) along much of their lengths, but there is also an estimated 600 m of basin fill in Washoe Valley (Peterson, 1993; Peterson and Karlin, 1997). The Washoe Valley fault thus has about twice the offset of the Little Valley fault, and net throw across the two faults is almost 2 km.

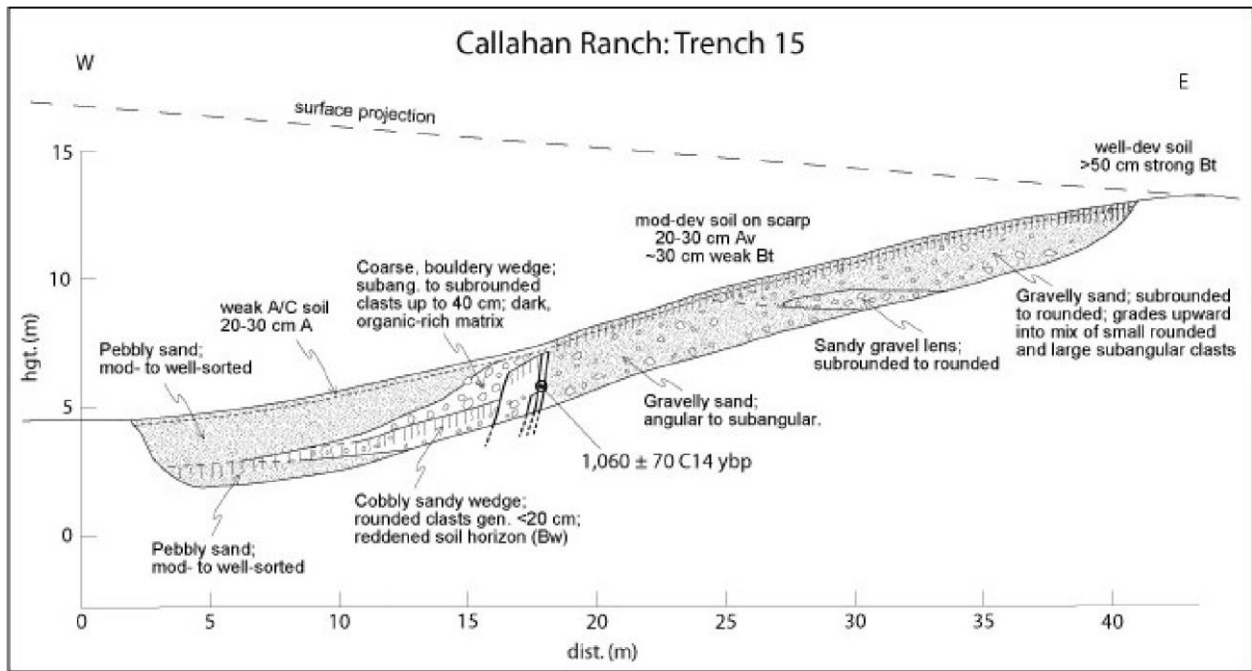
The deposits exposed in Trench 15 generally consisted of massive gravelly sands. The lack of distinct stratigraphy limited interpretation of events, but relations nonetheless indicate several events with up to a few meters of offset per event. The only datable material obtained from the trench was dark, organic-rich material within a fissure formed by the most recent event, which yielded a radiocarbon date of $1,060 \pm 70$ ybp (figure 4).

Figure 4: Log of Callahan Ranch Trench 15. See figure 3 for trench location.

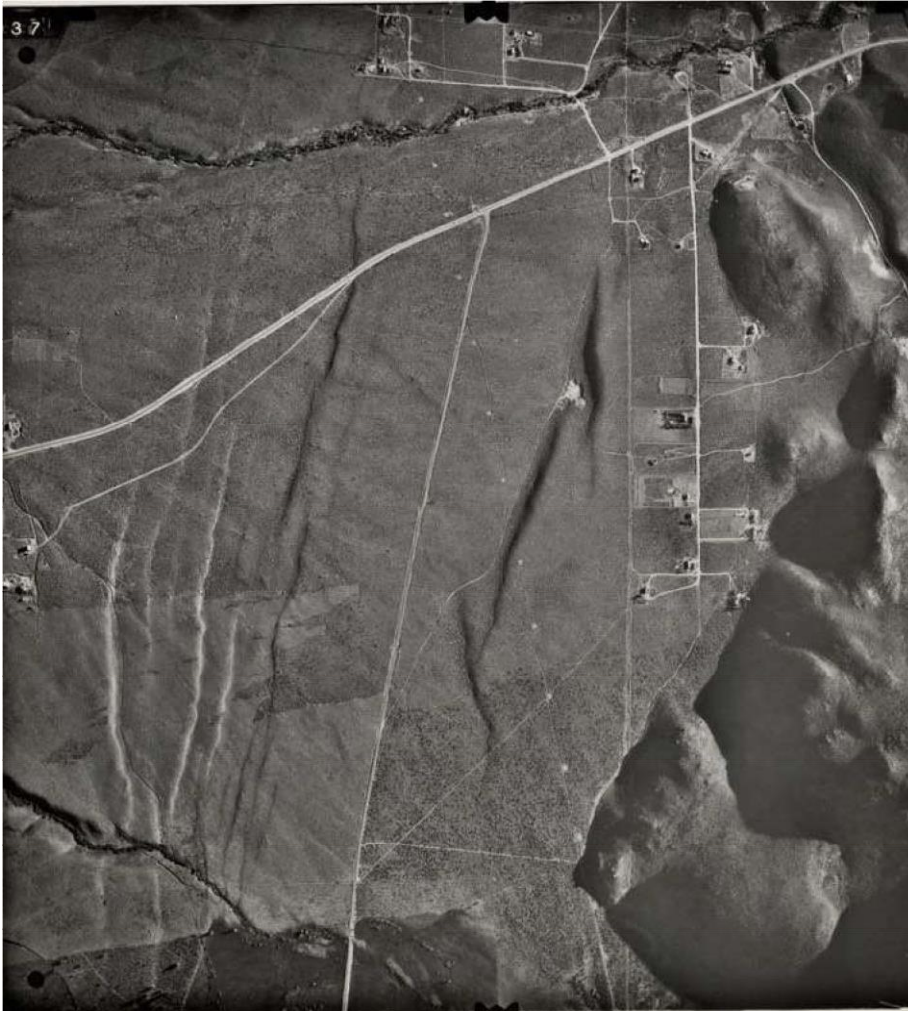
Figure 11: Low sun angle photograph of the Callahan Ranch area, southern Mt. Rose fan

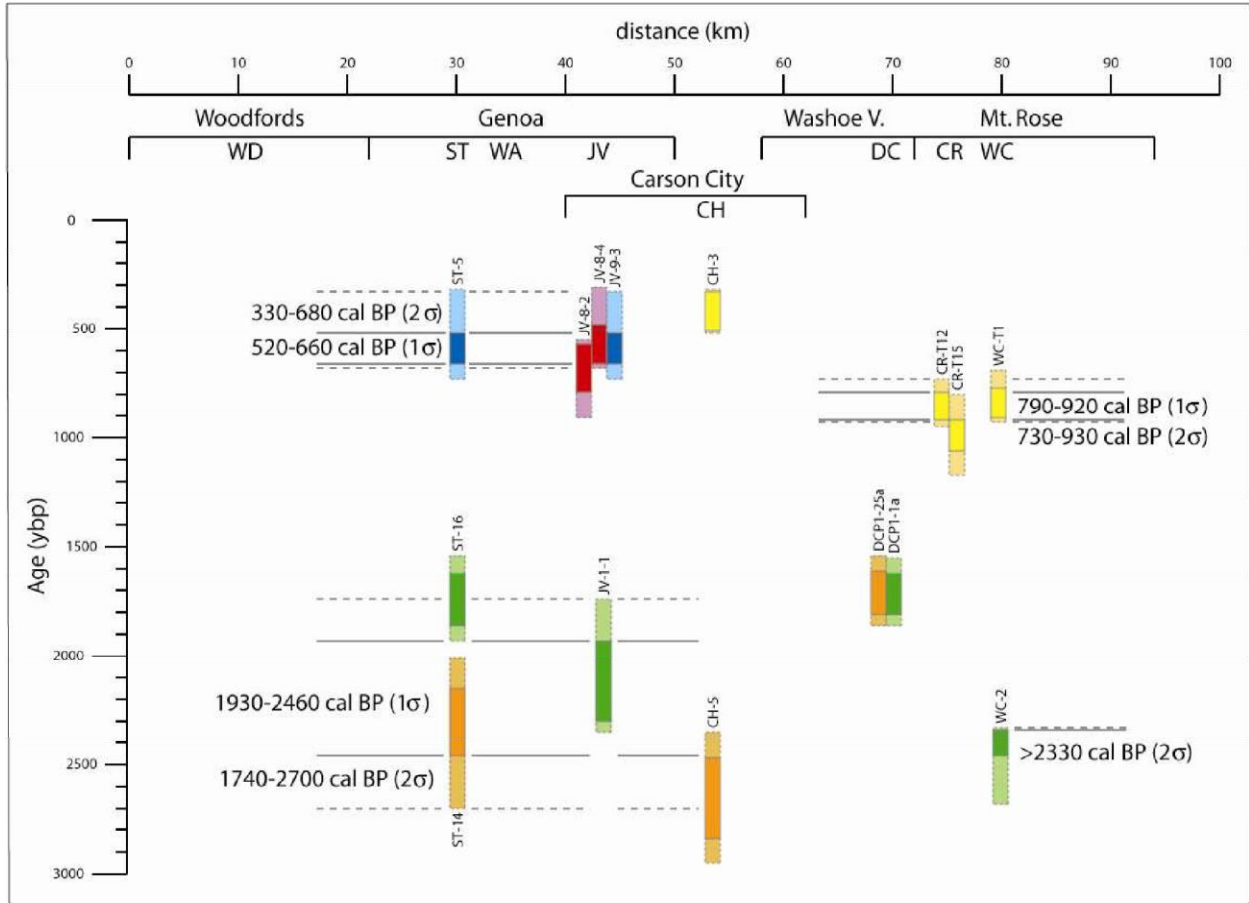
Age analyses for the Carson Range fault system as a whole were compiled and re-evaluated. The radiocarbon dates interpreted to provide the closest constraints on timing of the two most recent events on the Carson Range fault system are depicted in figure 21. These results suggest the most

Figure 21: Summary of radiocarbon age-control for the Carson Range fault system.

Blue=samples postdating MRE; red=samples predating MRE; yellow=samples approximating MRE; green=samples postdating penultimate event; orange=samples predating penultimate event. Dark colors=1 sigma ranges; light colors=2 sigma ranges.
