**GEOTECHNICAL INVESTIGATION
REPORT**

ASCENTÉ

Washoe County, Nevada

JN: 9019.004

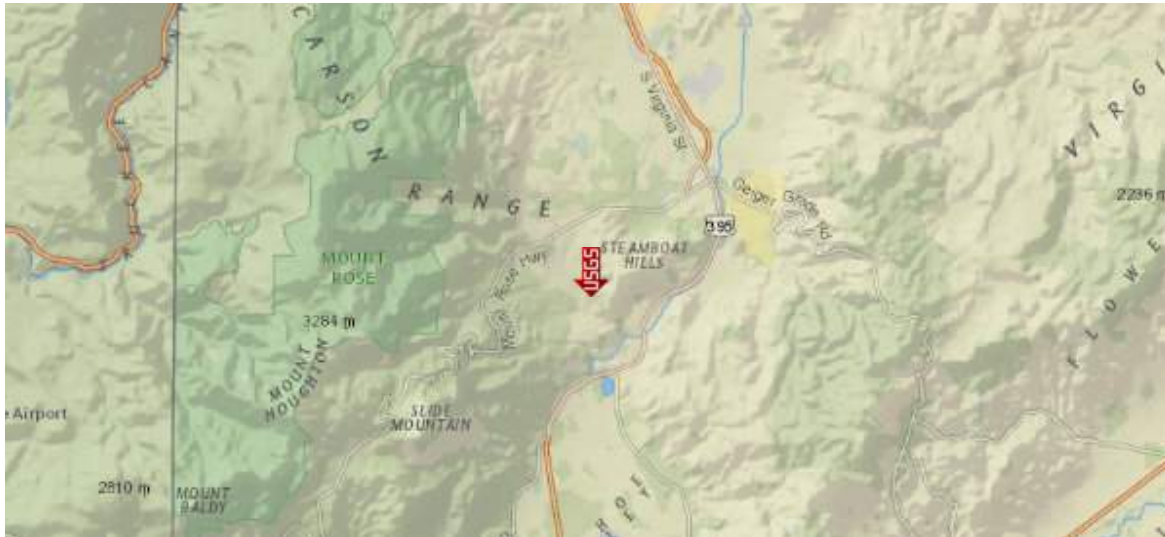
Site Soil Classification Site Class D – “Stiff Soil”

USGS-Provided Output

$S_s = 2.322 \text{ g}$	$S_{MS} = 2.322 \text{ g}$	$S_{DS} = 1.548 \text{ g}$
$S_1 = 0.813 \text{ g}$	$S_{M1} = 1.219 \text{ g}$	$S_{D1} = 0.813 \text{ g}$

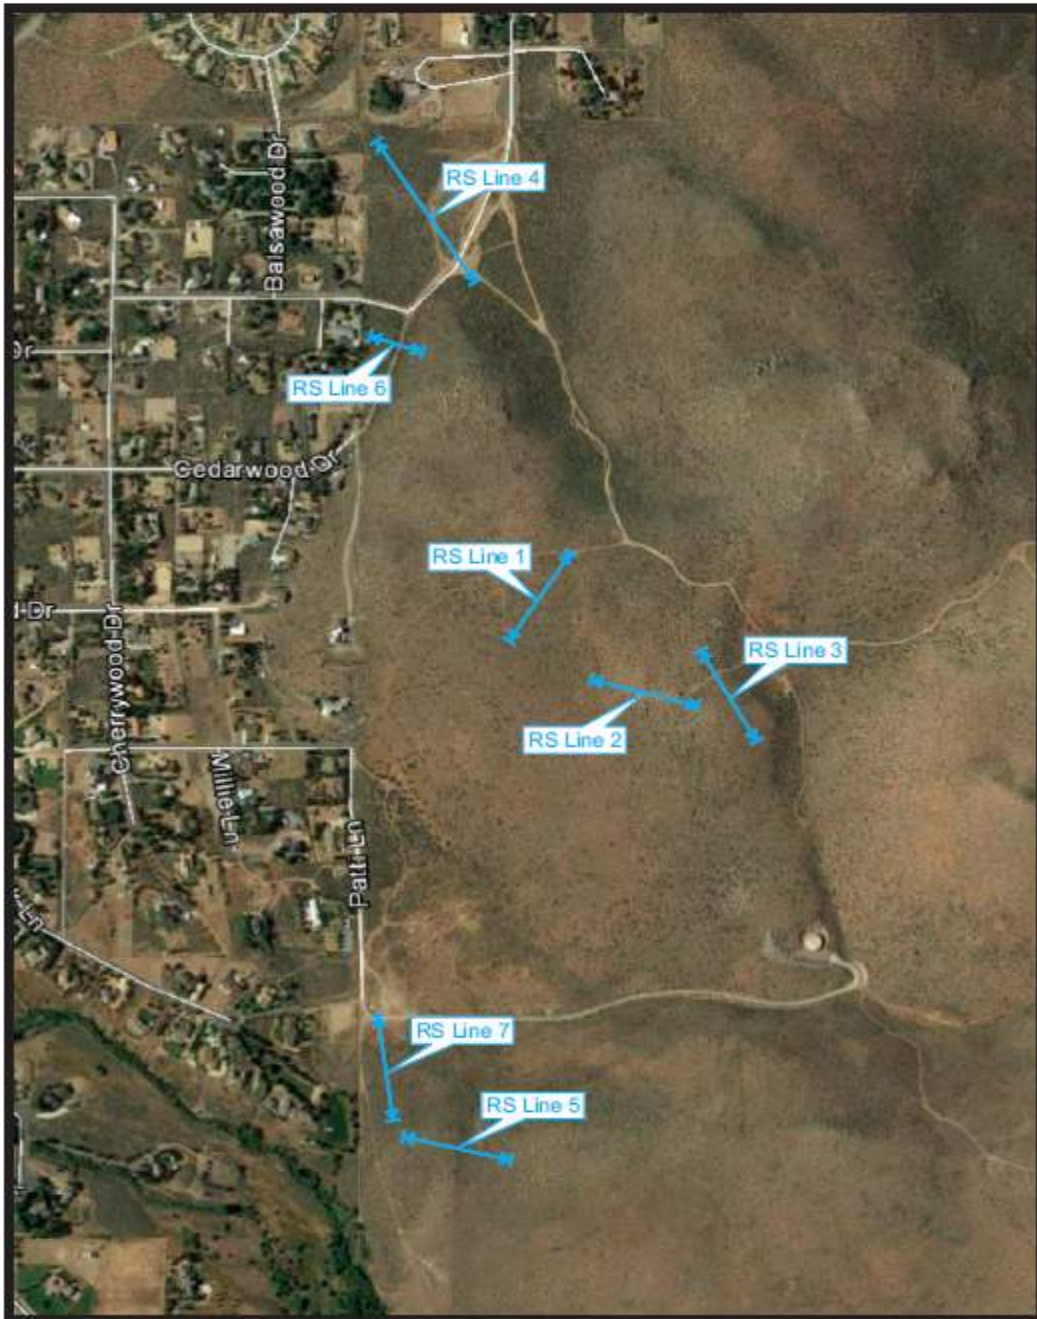
Figure 2

RS Line Location Map

I was asked by Mitch Burns to review the findings report submitted by Gasch Geophysics Services (GES) of Rancho Cordova, California. More specifically I was asked to review seismic line RS-4 in relationship to my interpretations of the fault scenario at the Ascente Property.

A shallow (100 feet deep) reverse circulation drill hole located in the center of the high on seismic line RS-4 would test the bedrock extension and hopefully help resolve the question.

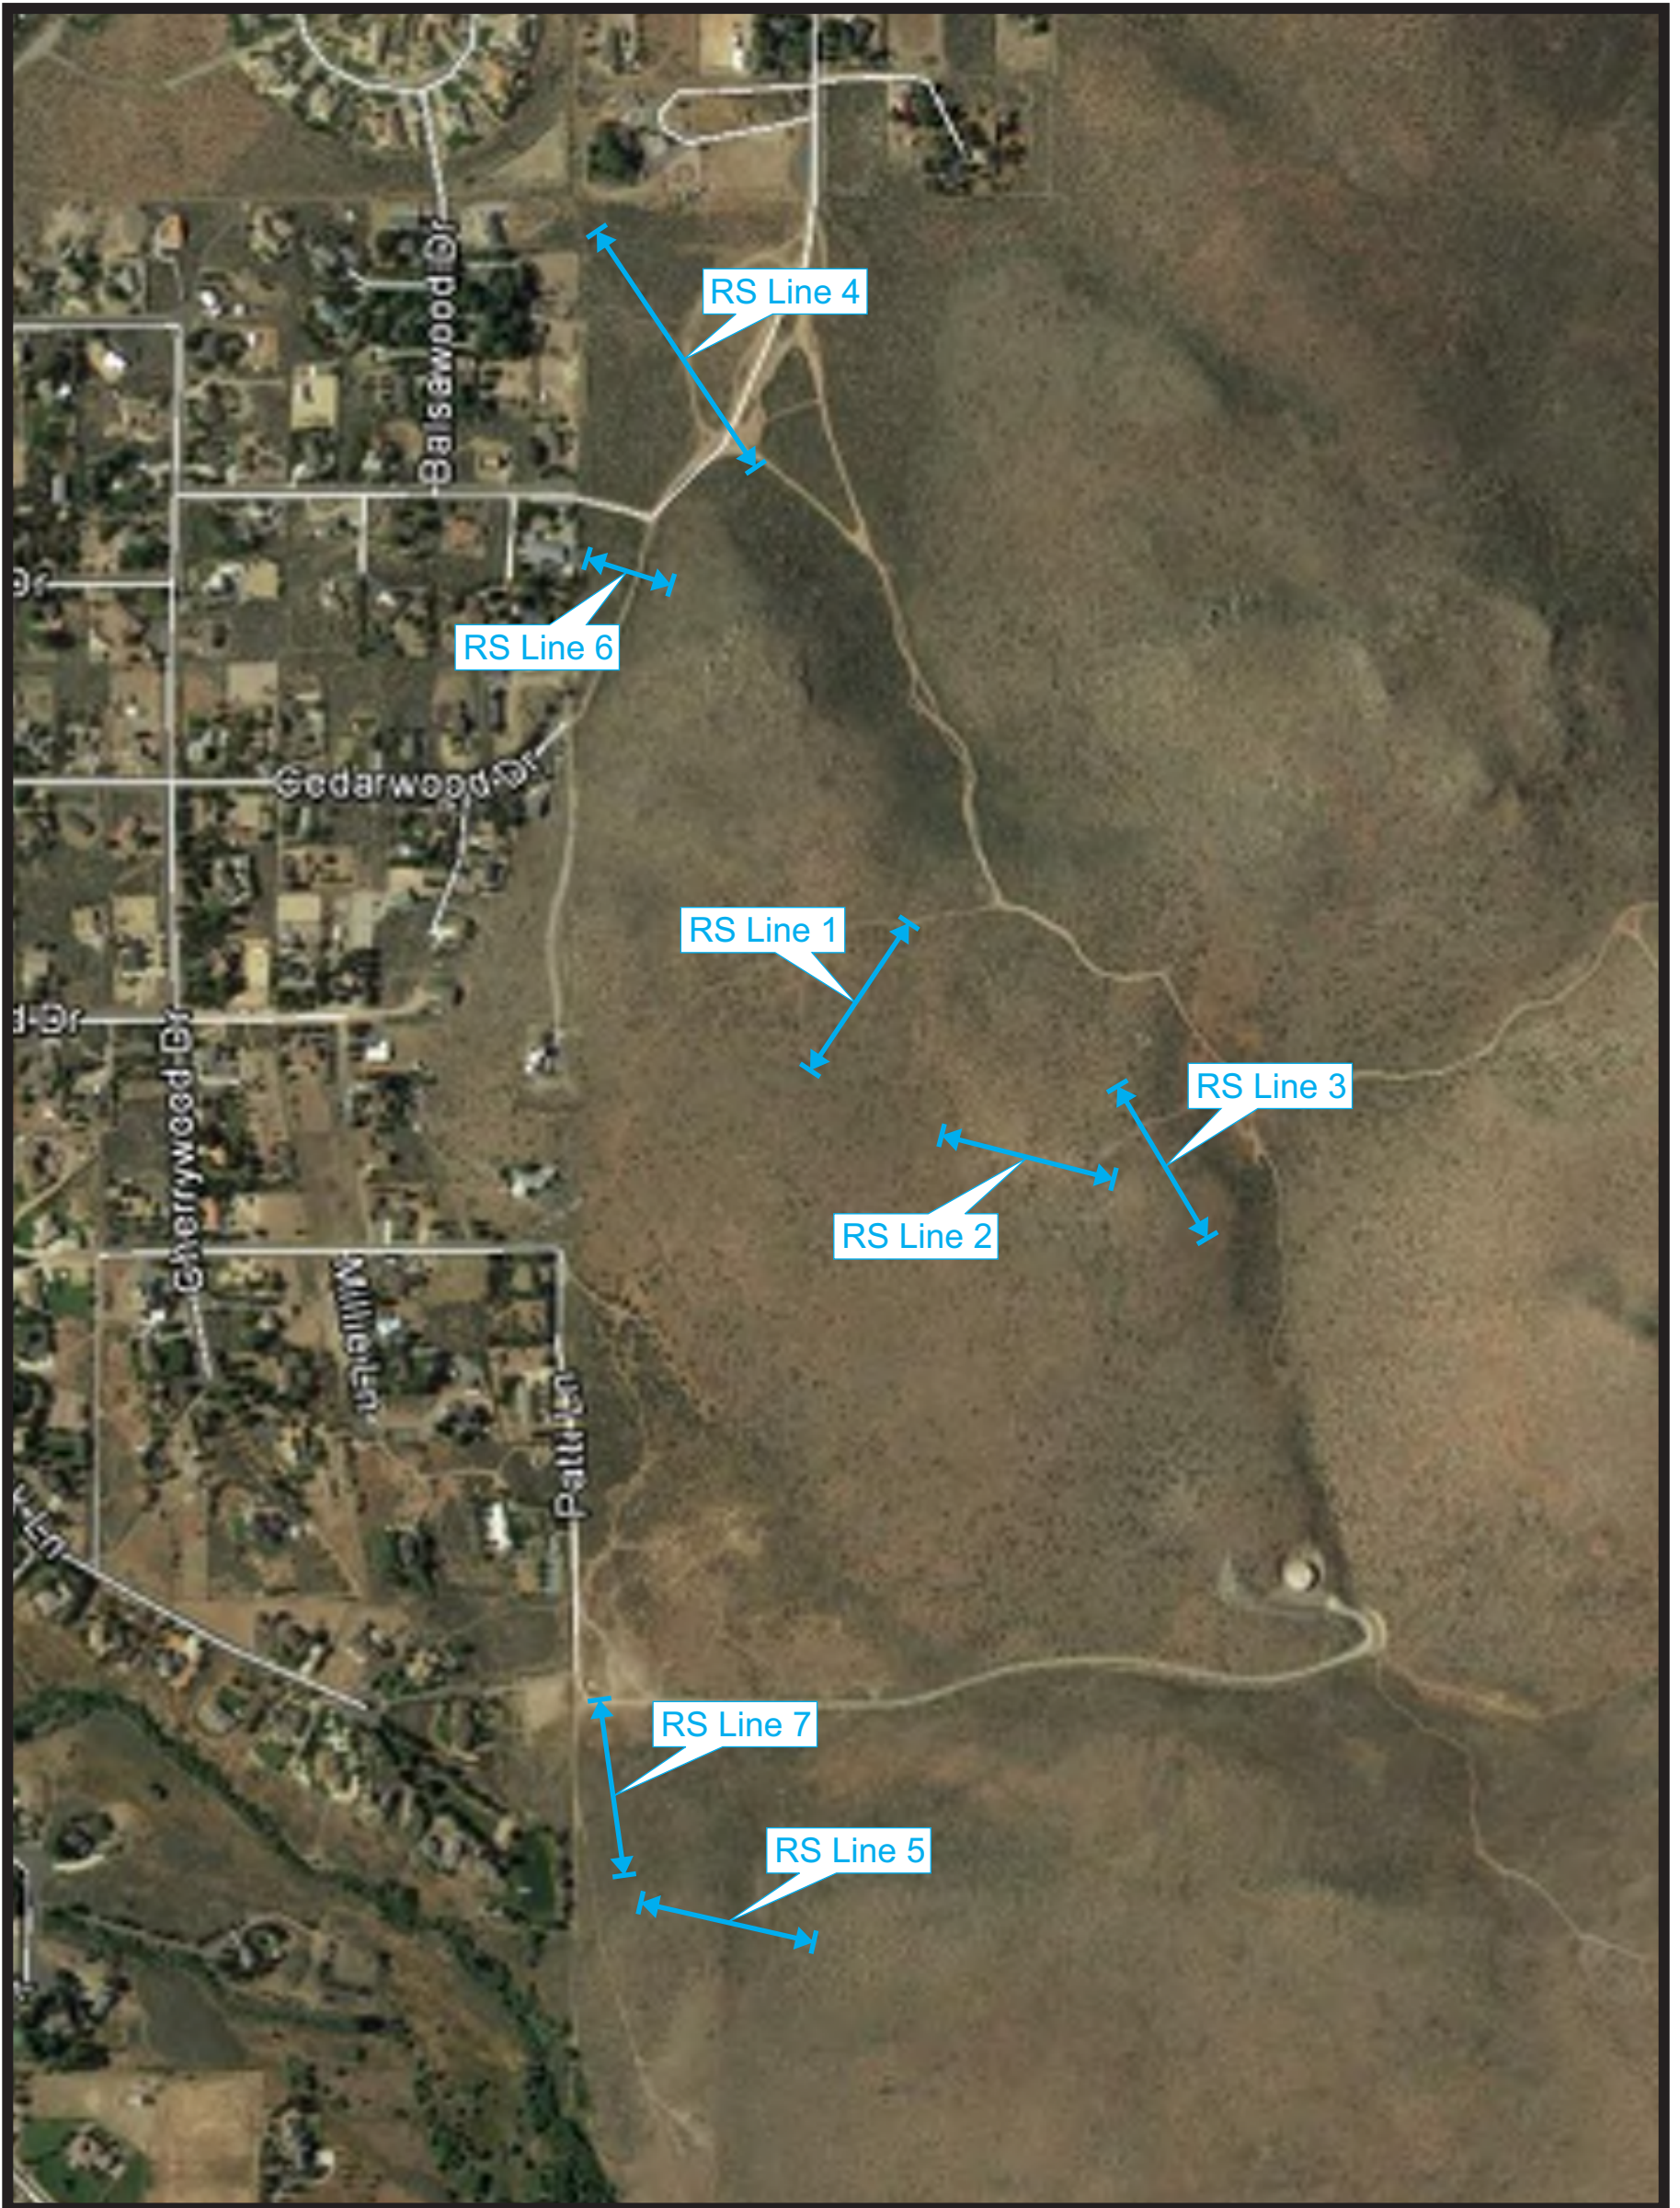
Figure 2

RS Line Location Map
