RE: Ascente Trenches

Re:Seismic Findings Report Issues – Ascente Project

Refraction Seismic Investigation:
Ascenté Development Site
Prepared for: Lumos & Associates
Project Number: 2017-29.01 Date: October, 2017

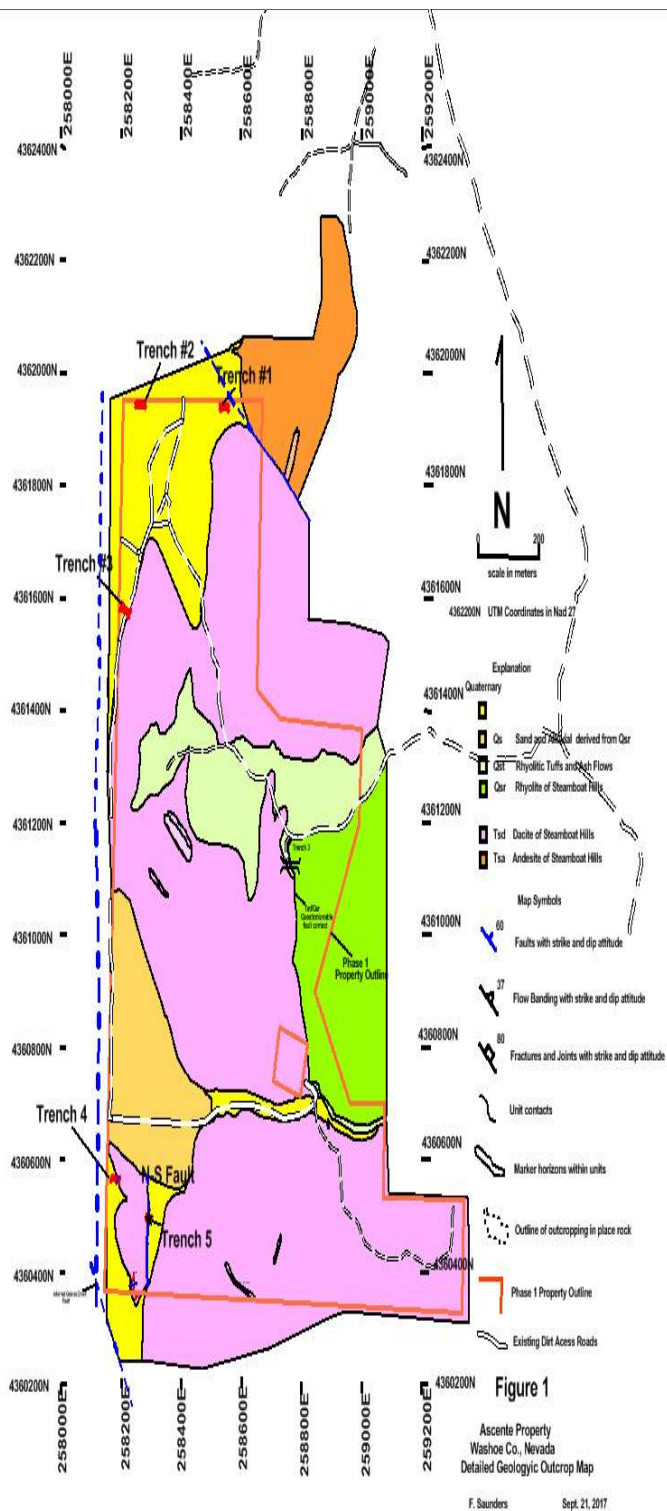
Figure 1 Geology Map showing 2017 trenches

I met Bert Sexton at the property on September 20, 2017 and we proceeded to Trench 1, located on the northeast corner of the property. The trench locations are plotted on figure 1 and the coordinates are tabulated in appendix A. Bert Sexton, the onsite engineer, supervised cutting the trenches that were located in the field by Mitch Burns of Lumos.

Trench 1 is a 55 foot long roughly east-west trench that parallels the north property line. It was designed to cut a N 50°W trending fault that is defined by linear contact separating andesite's and dacites. The trench did not extend far enough to the east to intercept the fault. The last few feet on the eastern end of the trench did have some iron stained clay that could indicate it was getting near the fault.

This trench is again an east-west trench located near the west edge of the property approximately 100 feet south of the turnoff to the water tower road. The trench was 80 feet long. It was designed to test the same north-south trending fault located near the west edge of the property. The trench did not cut the fault zone as the trench was located too far to the east. It did intersect a small N30°E near vertical fracture zone within the dacitic volcanics. This fracture is believed to an older feature as it is within the dacitic rocks and of little significance to the project.

The east-west trench was only 40 feet long. The west end of the trench was cut down 4 feet to outcropping dacite. At about $\frac{1}{2}$ way in the trench the fault was cut. The alluvial had a marked color change and represented a sharp drop off of basement depth. The trench was cut 15 feet deep on the east side of the fault and never encountered bedrock, thus indicating a vertical offset. This fault will need to have a 50 foot offset designed in the Ascente plot plan.

The projected core hole located east of the trench could be moved closer to the trench to see if it encounters bedrock at a reasonable depth.

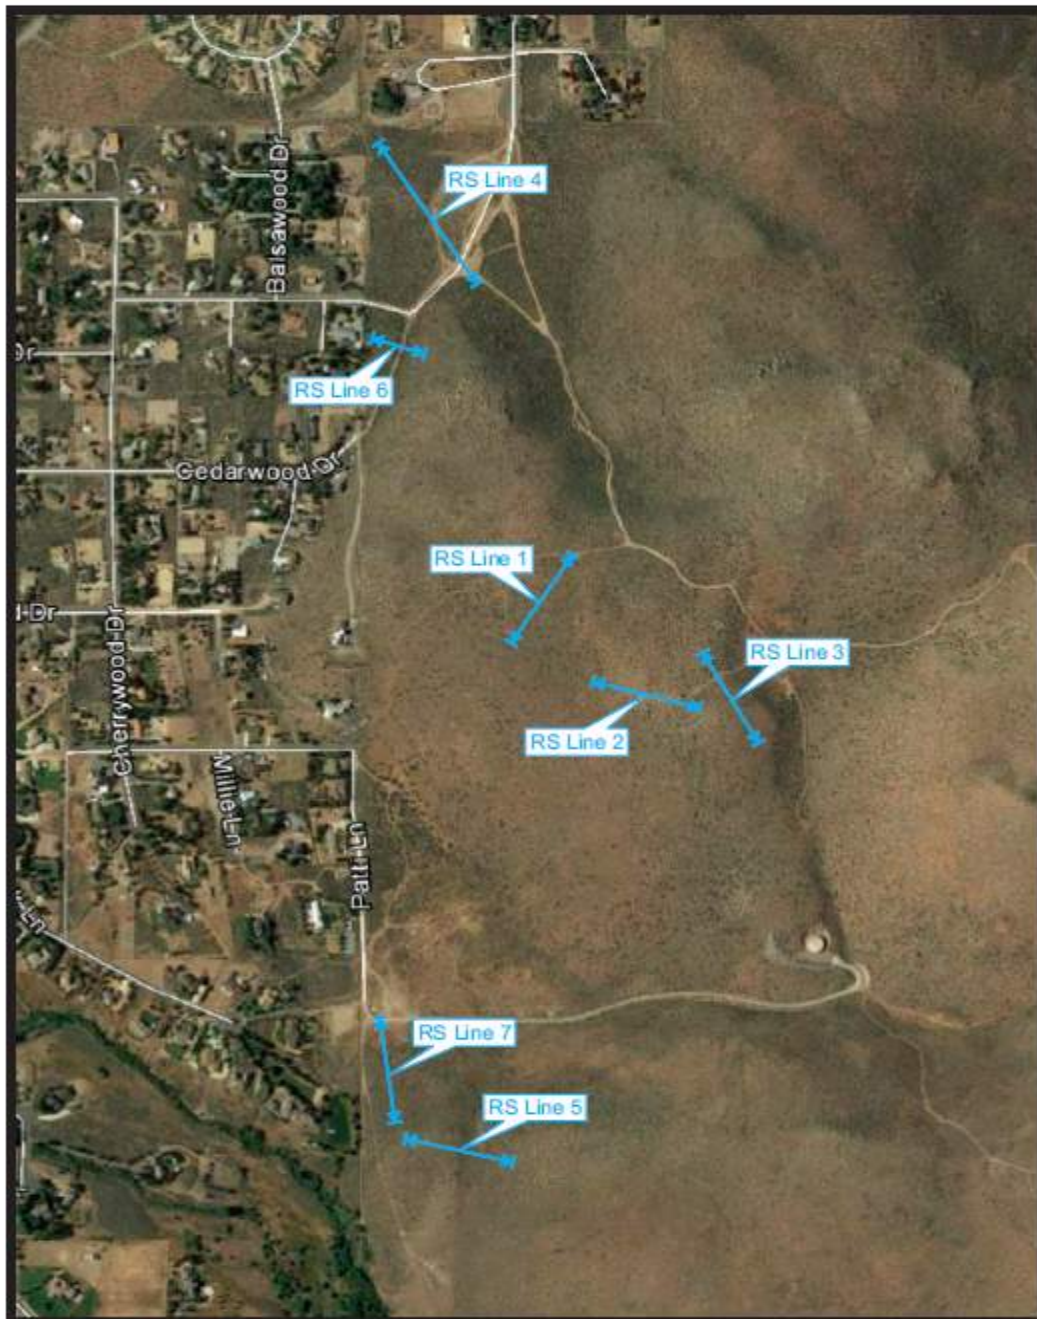
Figure 2

I reviewed the report and feel the possible fault zone in seismic line RS -4 could be reinterpreted as a bedrock or basement high. Seismic geophysics essentially measures variances in the density of the material that it encounters and reflects various sound waves velocities back to the surface. Denser rocks such as outcrops will reflect higher velocity sound waves than lower density rocks such as alluvial.

Line RS-4 on the does not show this same pattern. It shows a zone that GES has outlined as a possible fault zone in the Seismic Velocity Section – RS-4 as a higher density material surrounded on both sides by a lower

density material. Indicating this a bedrock high surrounded by gravels or alluvial shown in red on attached Seismic Line RS-4 profile.

This seismic anomaly is located just north of an outcropping ridge that is interpreted to extend out under the alluvial to the north as shown on the attached Ascente Geologic map and enlargement map . The attitudes, although somewhat chaotic on the geologic map, due roughly indicate that the outcropping ridge of dacite bedrock is elongated in a north-south direction and dipping back to the west, which is what the seismic data indicates.

RS Line Location Map

A shallow (100 feet deep) reverse circulation drill hole located in the center of the high on seismic line RS-4 would test the bedrock extension and hopefully help resolve the question.
